Manhole Inspection Summary

Manhole # S41C__010MH

Insp Date: **7/24/08 11:57 AM**

Location Address: **1439 N Caroline ST**

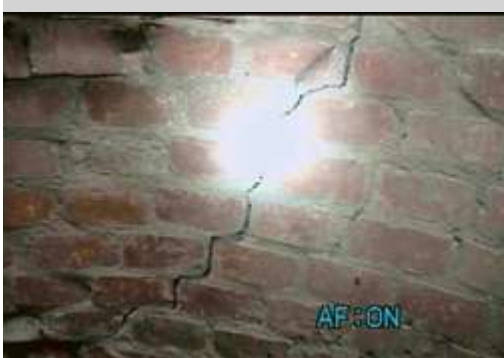
Defect 3

Condition: ☐ Sound ☒ **Cracked** ☐ Root Intrusion ☐ Loose Brick ☐ Deteriorated

barrel cracked

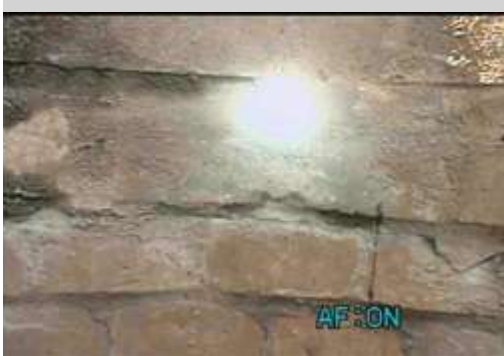
Defect 1

Condition: ☐ Sound ☒ **Cracked** ☐ Root Intrusion ☐ Loose Brick ☐ Deteriorated

chimney cracked, frame adjustment
